Calcine Retrieval Project

Radiation Testing Report

RPT-2052
Revision 0

Idaho Cleanup Project
Idaho Falls, Idaho 83402

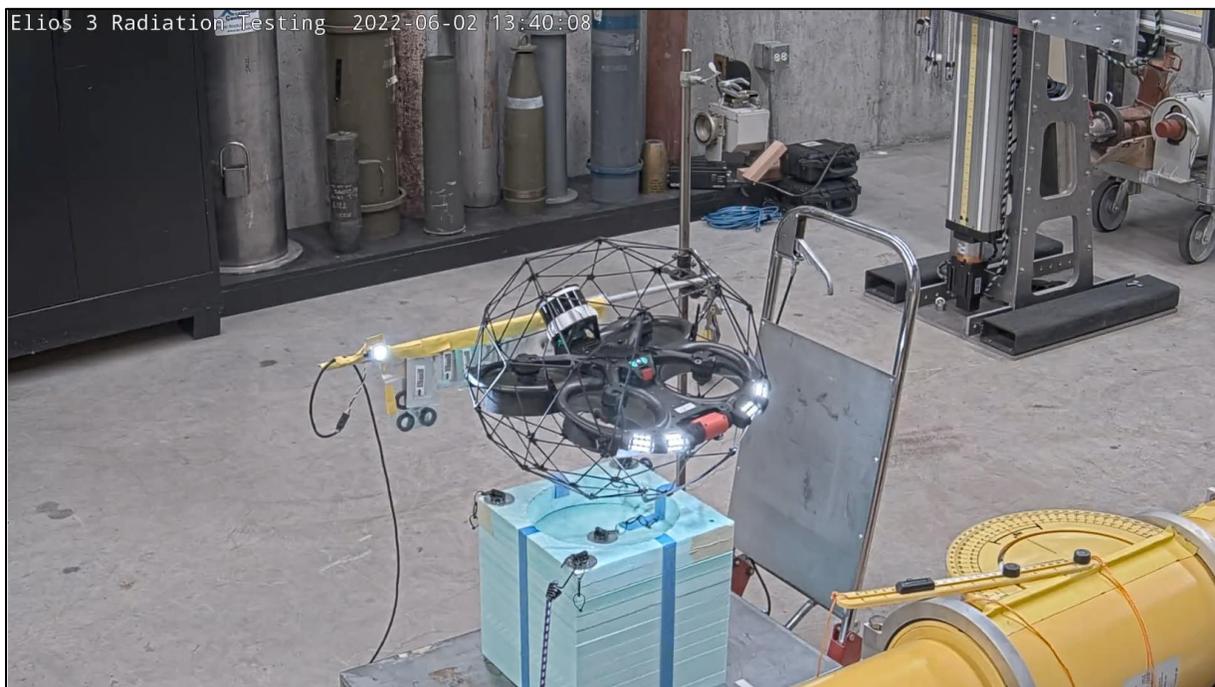
Figure 12. Elios 3 drone in stable flight during a 10,000 R/h radiation exposure

The drone was subjected to increasing radiation field strengths in a stepped fashion ranging from 600 R/h up to 10,000 R/h. The drone was irradiated while in a controlled hover in line with the X-ray beam. The drone was tethered to ensure it did not damage itself or other equipment in the X-ray vault should a control system failure occur. Figure 12 shows the drone in a controlled hover while exposed to a radiation field of 10,000 R/h.

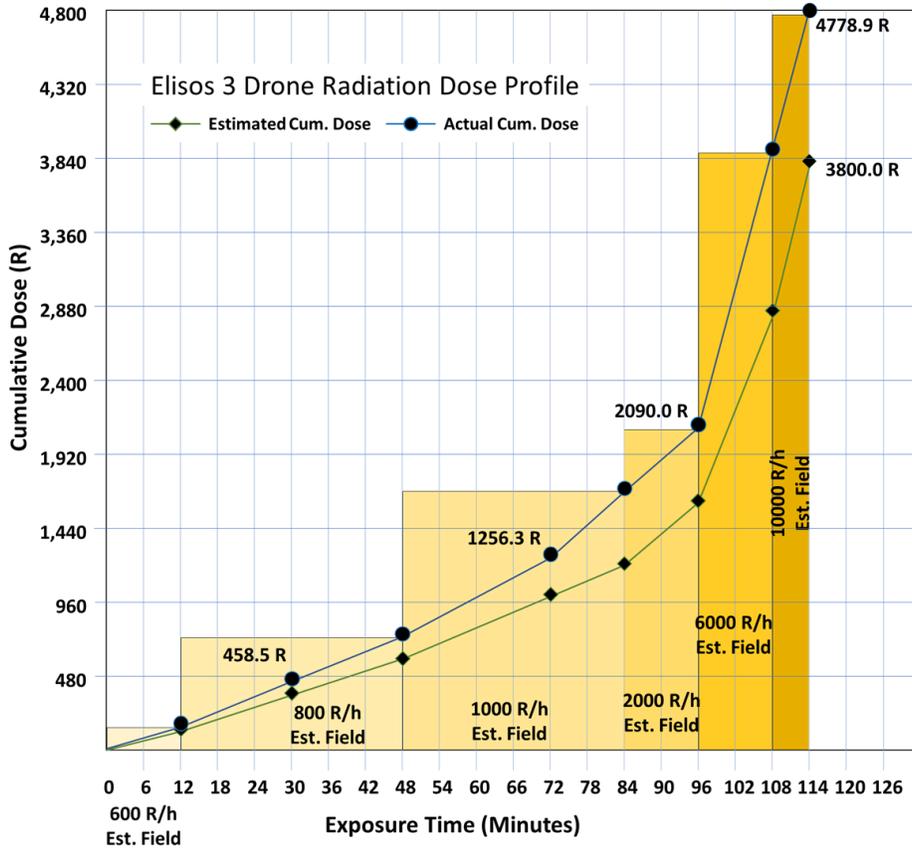
Figure 14. Graph representing the stepped radiation test results for the Elios 3 drone

When preparing for the second 10,000 R/h irradiated flight, the drone failed to initialize indicating a problem with data storage on the on-board computer (OBC). This error could not be cleared and prevented any further radiation testing on the drone. A detailed assessment by Flyability engineers is planned to determine if this error was caused by radiation or if it was due to some other problem. This OBC error was the only issue observed by the test team. All other systems on the drone, including the LiDAR and high-resolution camera, continued to function as designed.

Table 4 and the chart in Figure 14 provides a detailed summary of the stepped radiation profile the Elios 3 drone was subjected to. The actual dose values shown are derived from the average value of dosimetry readings placed directly in front of and behind the drone during test. The estimated dose values are calculated using an estimated field strength at a point directly at the center of the drone.

CRP engineers will continue to work with Flyability engineers to obtain information regarding on-board computer fault.

CRP engineers will continue to work with Flyability engineers to determine the cause of the OBC failure on the drone and then determine if additional radiation testing on the drone is needed. This information will be documented in a follow-on report.

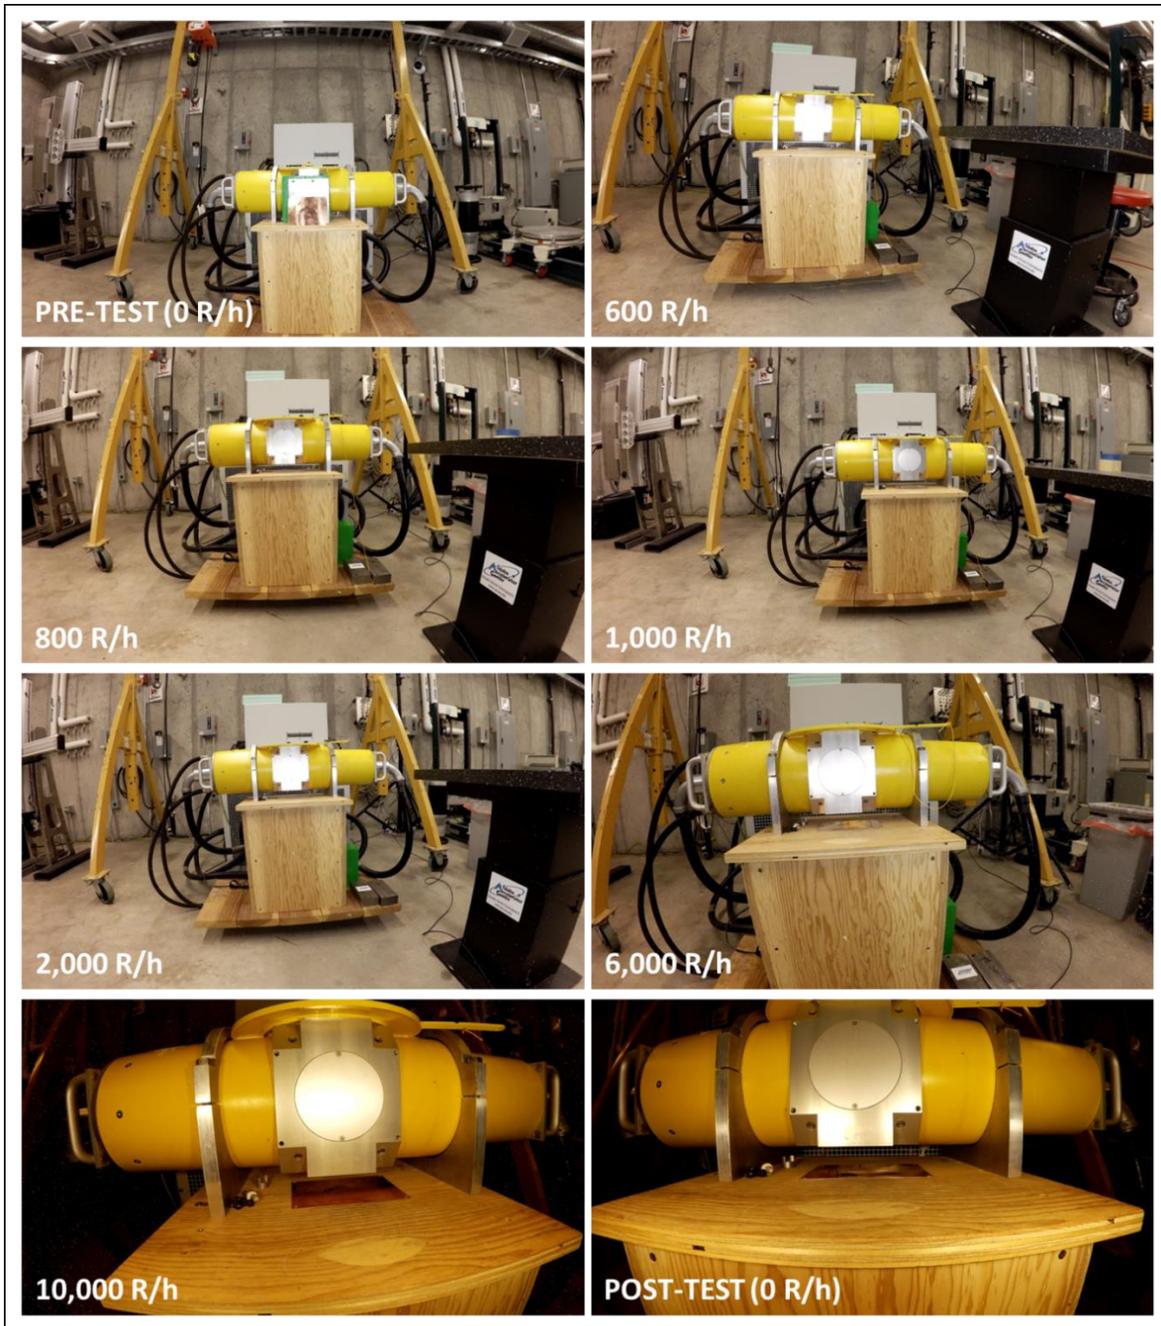
Figure 15. Comparison of drone camera images taken in varying radiation fields

The downloaded 4K imagery and LiDAR data indicated that these systems performed well throughout the radiation testing profile shown above. Images pulled from the downloaded drone video show an increase in radiation induced noise on the camera sensor as the radiation field strength increased. But, after the X-rays were shut off, there appeared to be no permanent damage to the camera sensor. Figure 15 provides a comparison of drone camera images taken while operating in different radiation field strengths. Even at 10,000 R/h, the image quality is very good. Figure 16 shows an expanded section of the 10,000 R/h image to show the amount of radiation induced noise compared to an image with no radiation.

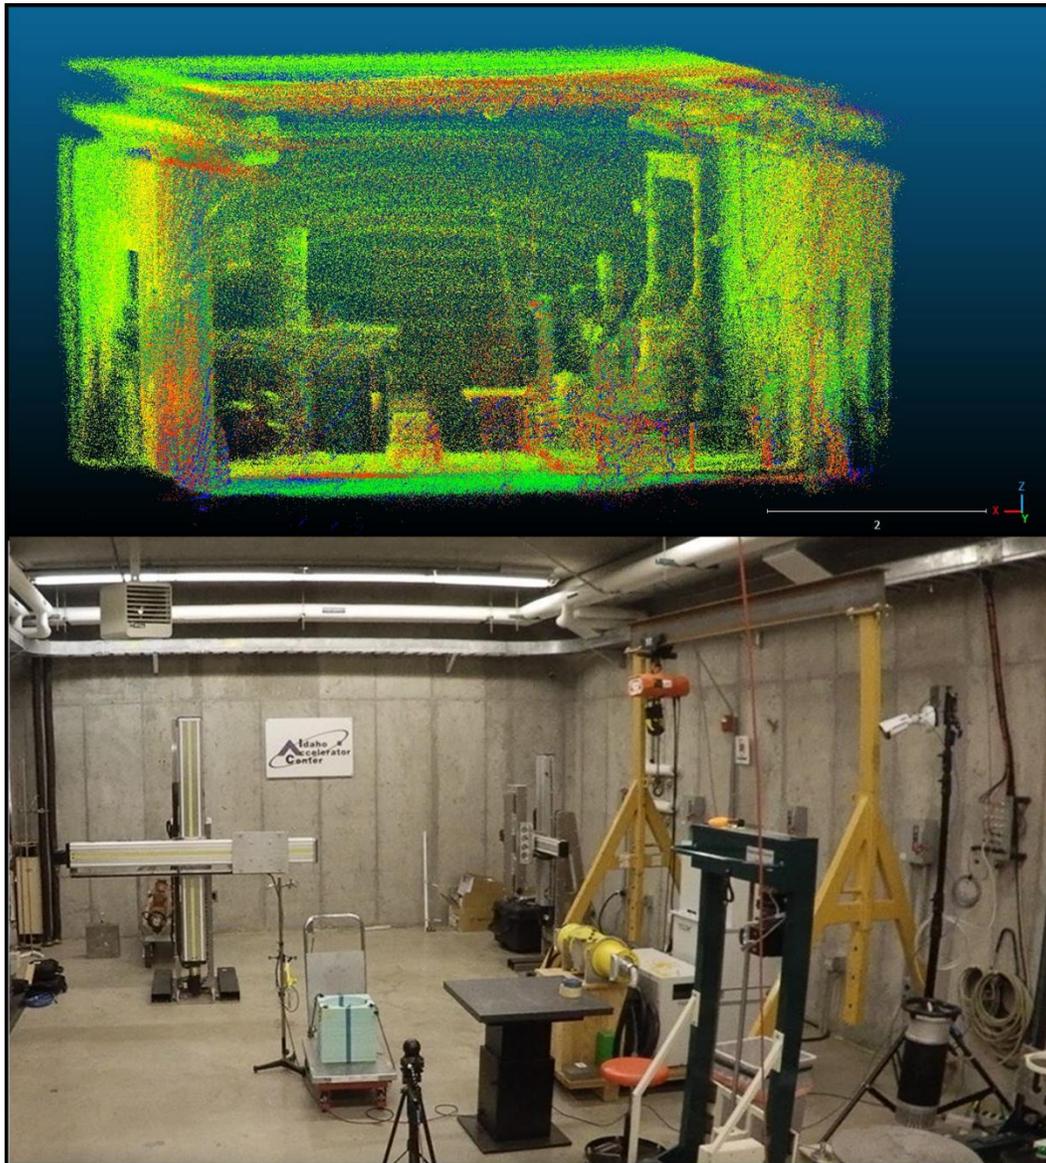
Figure 17. Low-resolution point cloud image (top) collected by Elios 3 drone LiDAR during test flight after 10,000 R/h exposure. X-ray vault image (bottom) provided for reference

The Elios 3 drone's LiDAR payload is a critical subsystem that will be used to collect the 3D map data within the CSSF-1 vault. During radiation testing of the drone the LiDAR payload continued to operate as designed throughout the radiation exposure profile indicated above. Figure 17 provides a low-resolution rendering of the X-ray vault created from LiDAR data collected during the test flight after the 10,000 R/h radiation exposure along with a photo of the vault for reference. This low-resolution point cloud image was rendered using CloudCompare, an open-source software package. This software was used only to provide a rough verification of the LiDAR data collected by the Elios 3 drone during radiation testing.

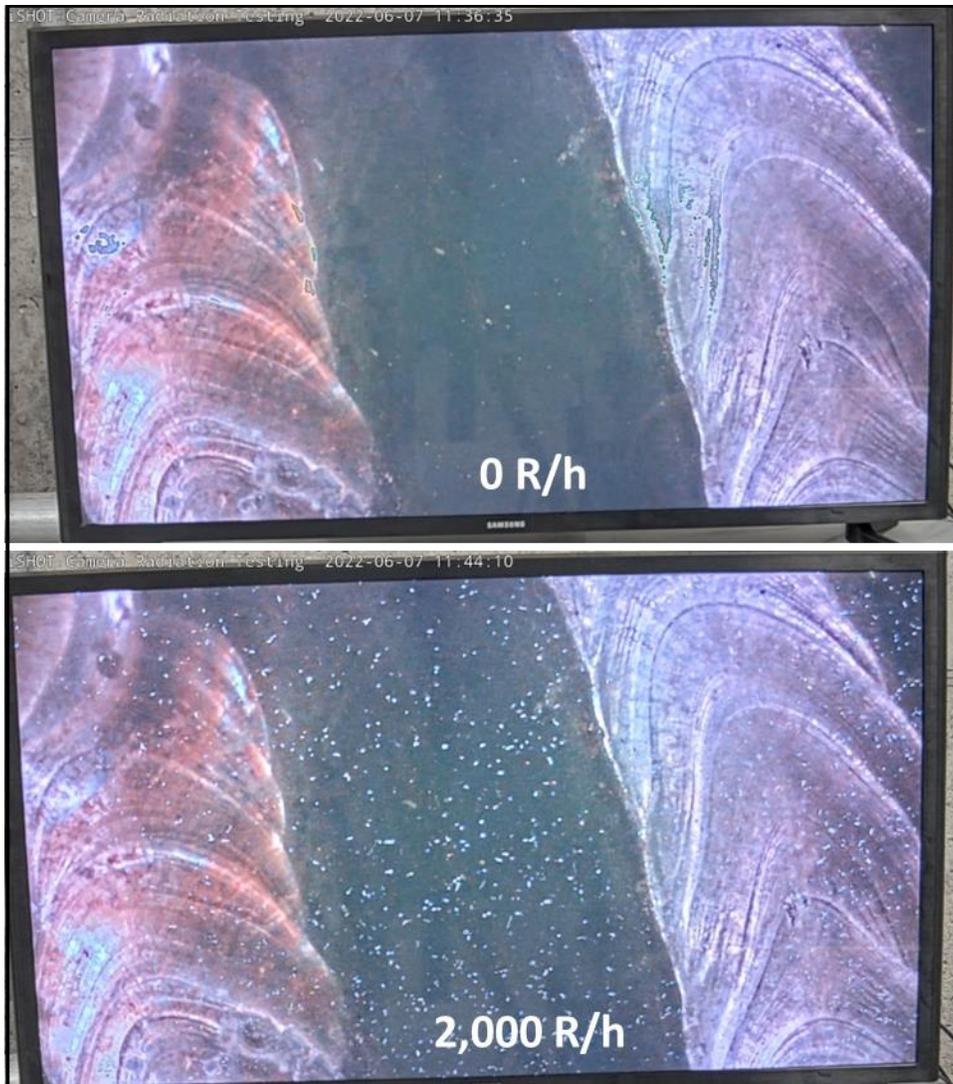
Figure 19. iSHOT camera image of weld sample taken with no radiation (top) and while operating in a 2,000 R/h field

The iSHOT camera image contained observable radiation induced noise when exposed to the 2,000 R/h radiation field but did not show any indication of permanent sensor degradation after 7,119 R of accumulated dose.

Figure 19 provides a comparison of the iSHOT camera image captured with no radiation and while operating in a 2,000 R/h field.

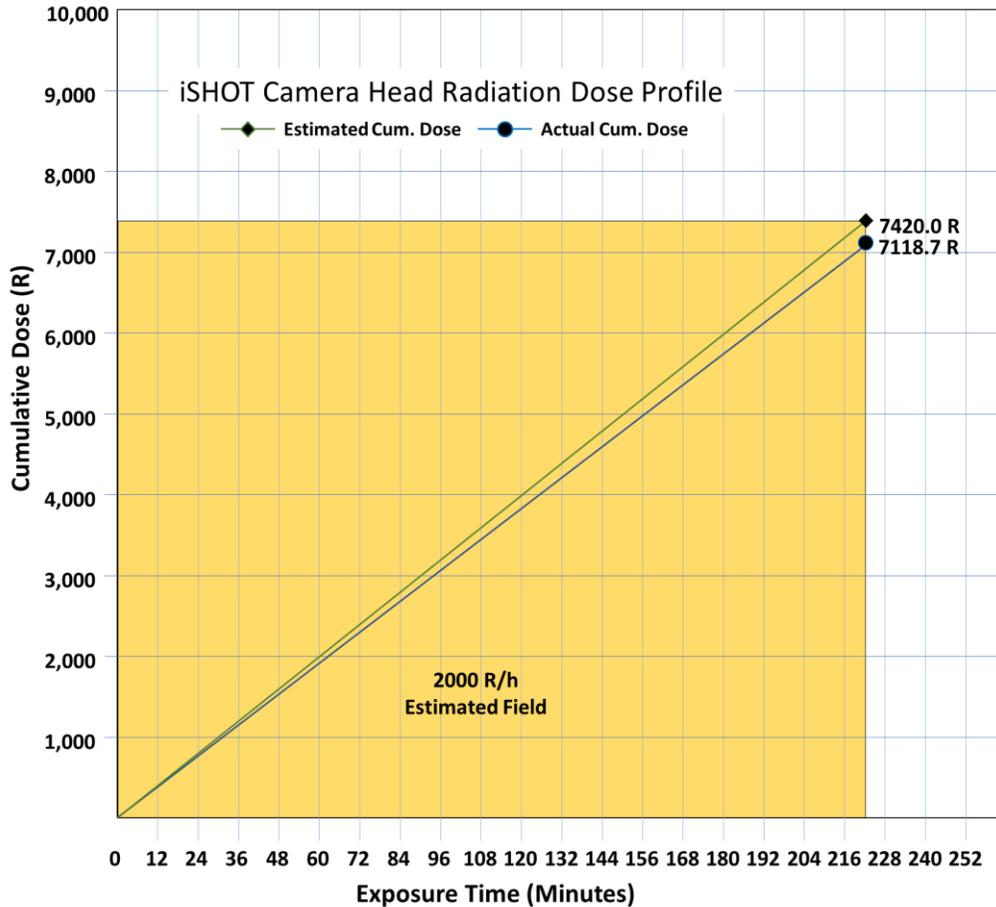
Figure 20. Graph representing the stepped radiation test results for the iSHOT weld camera head

The graph showing the iSHOT camera head radiation exposure profile is provided in Figure 20. The lamp function on the camera head was turned on several times throughout the 3.6 hours of exposure. There was no visibly detectable degradation of the lamp performance due to radiation exposure.

Although, the iSHOT camera control unit was located approximately 25 feet to the side of the X-ray tube, well outside the 40-degree beam, a GAFChromic dosimetry tag placed on the control unit prior to test indicated a total dose of 1,126 R received over the 3.6 hours of camera head exposure. This means the iSHOT control unit operated successfully in a radiation field of approximately 313 R/h with a total accumulated dose of 1,126 R.

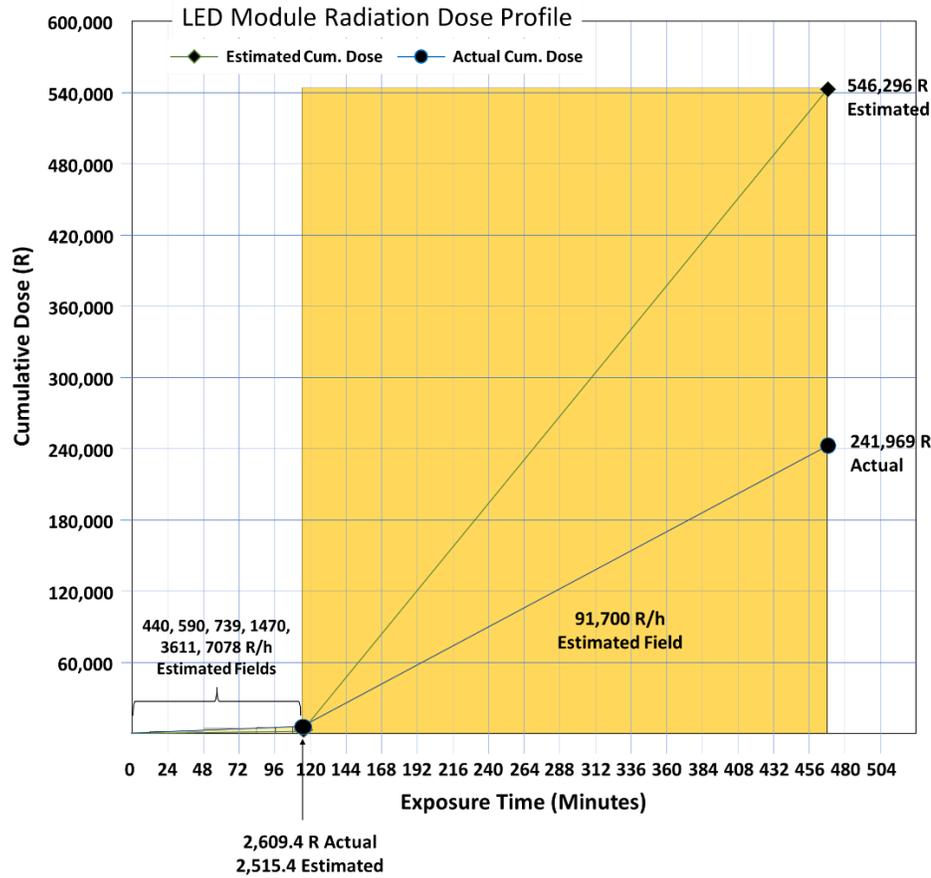
Figure 21. Radiation test profile for the surface cleaning tool LED module

Figure 21 shows the radiation exposure profile for the Surface Cleaning Tool LED module. The difference in estimated total dose and actual total dose at 468 minutes of exposure time is most likely due to overexposure of the GAFChromic dosimetry film. Although the dosimetry indicates a total dose of 241,969 R, it is appropriate to assume the true dose is significantly higher and closer to the estimated total

dose of 546,296 R. At 114 minutes of exposure time, the estimated dose and actual dose as determined using the nanoDots dosimetry are in alignment.

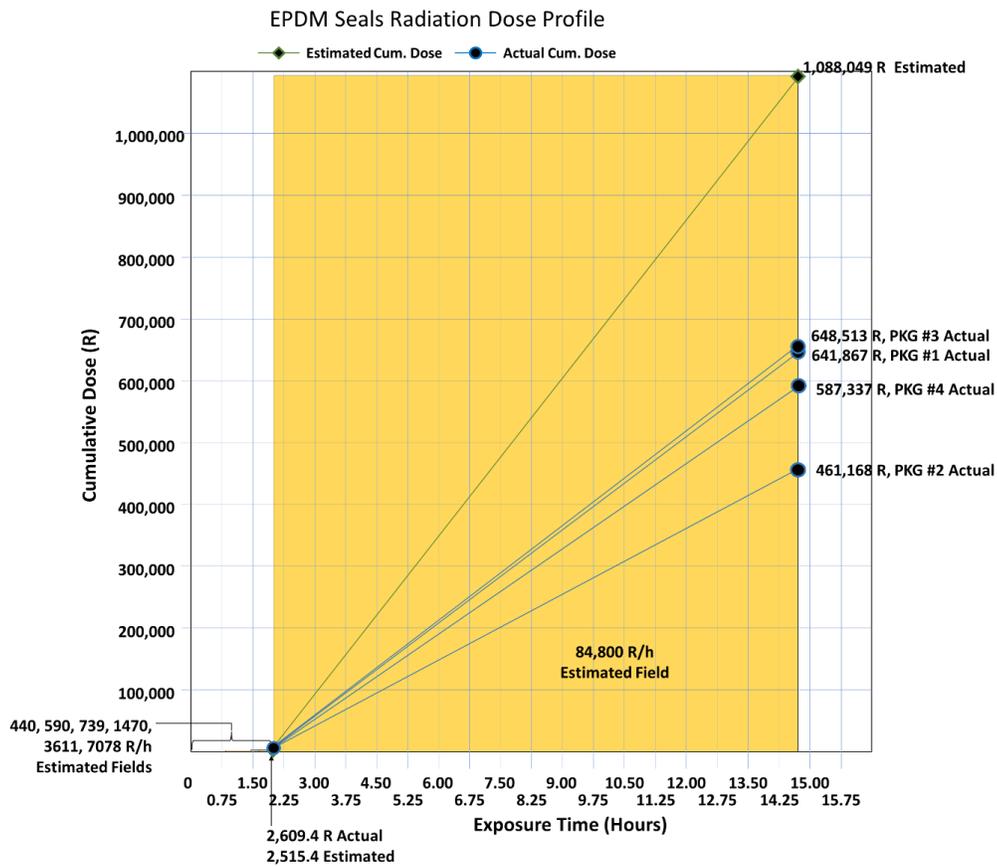
Figure 23. Radiation exposure profile for EPDM U-cup seals testing

GAFChromic dosimetry film indicates the four EPDM U-cup seal packages received total doses of 641,867 R, 461,168 R, 648,513 R, and 587,337 R.

Figure 23 provides the radiation exposure profile for the EPDM U-cup seals. The difference in estimated total dose and actual total dose at 14.7 hours of exposure time is most likely due to overexposure of the GAFChromic dosimetry film. Although the dosimetry indicates an average total dose of 584,721 R for the four packages of seals, it is more likely the true dose is significantly higher and closer to the estimated total dose of 1,088,049 R. At 114 minutes of exposure time, the estimated dose and actual dose as determined using the nanoDots dosimetry are in better alignment.

Future radiation testing will subject the EPDM U-cup seals to additional radiation dose to meet the original test objectives. The radiated seals will then be compared to a set of non-radiated seals. Future testing will also consider irradiating the EPDM seals while under compression to more closely test per intended use.
