Calcine Retrieval Project

Radiation Testing Report

RPT-2052
Revision 0

Idaho Cleanup Project
Idaho Falls, Idaho 83402

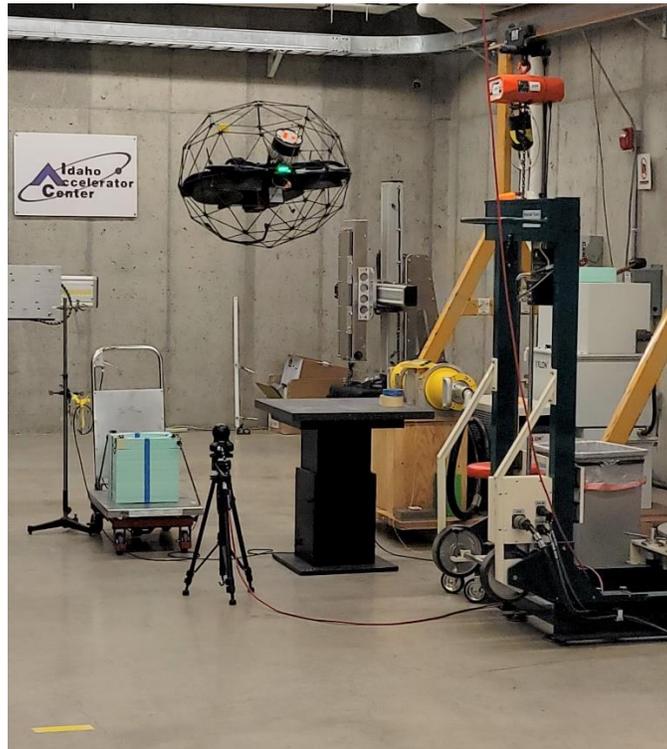
At the end of each six-minute irradiated flight, the X-ray source was shut off. The pilot then landed the drone on the test stand and placed it in standby mode. Test personnel entered the vault and removed the tether from the drone. The pilot then conducted a two-minute test flight within the X-ray vault to verify all systems on the drone were still functioning correctly and to collect LiDAR data. Figure 13 shows the Elios 3 drone conducting a successful, untethered test flight following a six-minute irradiation at 10,000 R/h.

Figure 13. Elios 3 drone conducting a successful, untethered test flight after 10,000 R/h irradiation

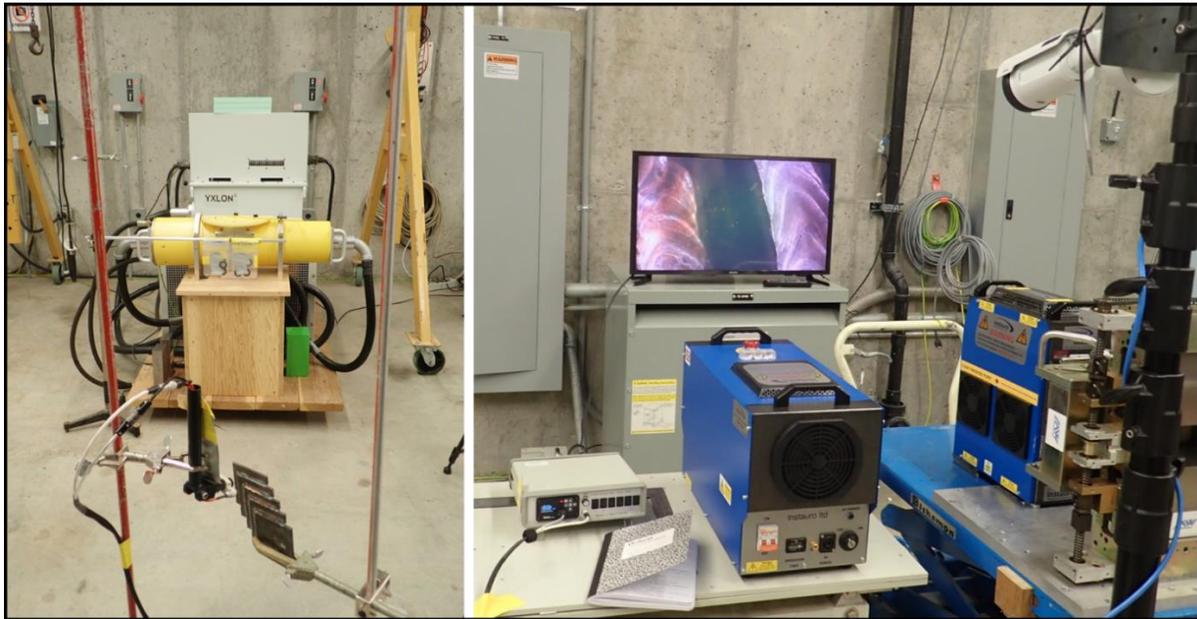
The iSHOT camera was exposed to a 2,000 R/h field for 3.6 hours while the camera operated. The camera did not fail during testing. An observation camera inside the X-ray vault was used to record and monitor images from the iSHOT camera that were displayed on a high-definition video monitor as shown in Figure 18.

Figure 18. iSHOT camera head and weld test specimen (left) and iSHOT camera control unit, high-definition monitor, and observation camera (right)

The iSHOT camera image contained observable radiation induced noise when exposed to the 2,000 R/h radiation field but did not show any indication of permanent sensor degradation after 7,119 R of accumulated dose.

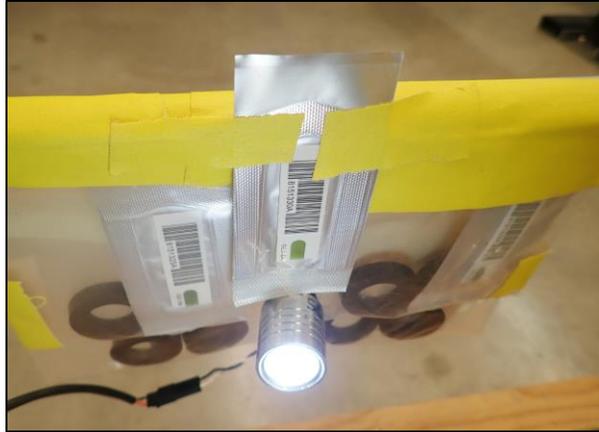
GAFChromic dosimetry film indicates the four EPDM U-cup seal packages received total doses of 641,867 R, 461,168 R, 648,513 R, and 587,337 R.

The EPDM U-cup seals were co-located with the drone during the first 114 minutes of radiation exposure. Once radiation testing on the drone concluded, the seals were moved to within 260mm of the source to greatly increase the rate of dose accumulation for the remainder of test time. Figure 22 shows the four packages of EPDM U-cup seals and the Surface Cleaning Tool LED module during radiation testing.

Figure 22. EPDM U-cup seals and Surface Cleaning Tool LED module during radiation testing
