FLYABILITY

ELIOS 3

## **March release notes**

April 4th, 2023

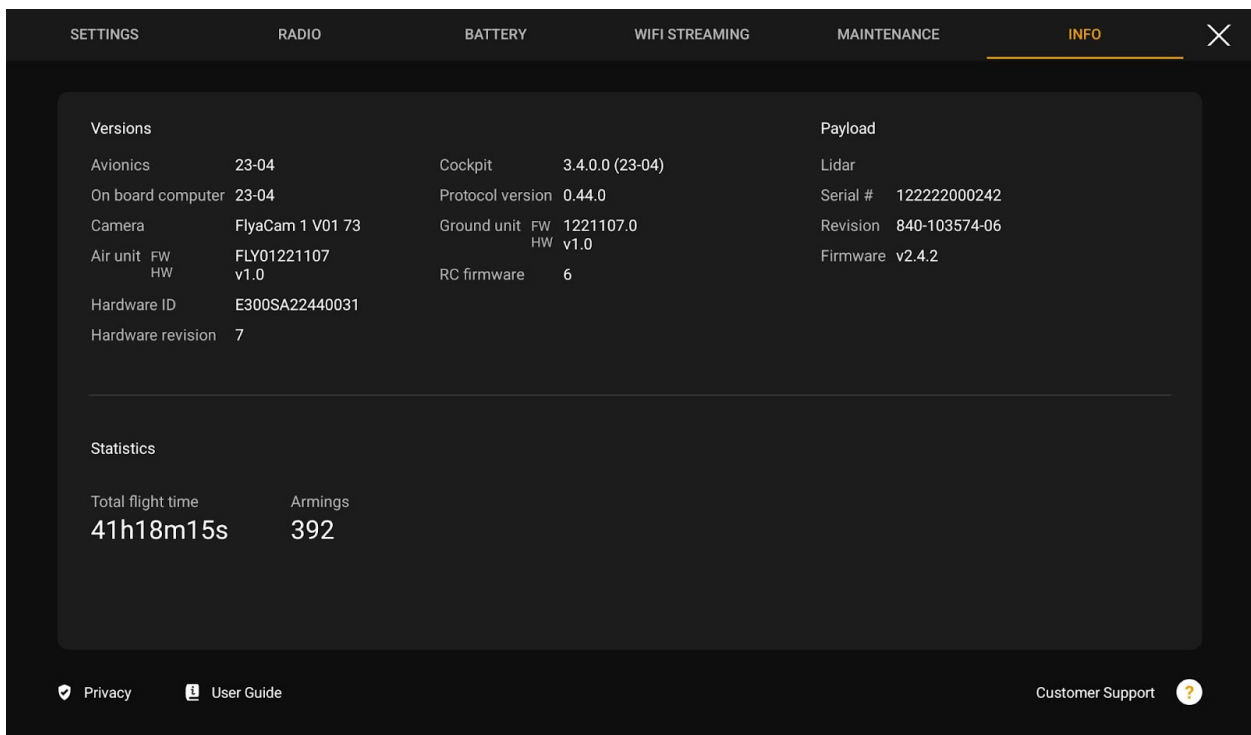
INFO panel version after update

The screenshot shows the 'INFO' panel with the following data:

Versions		Payload	
Avionics	23-04	Cockpit	3.4.0.0 (23-04)
On board computer	23-04	Protocol version	0.44.0
Camera	FlyaCam 1 V01 73	Ground unit FW	1221107.0
Air unit FW	FLY01221107	HW	v1.0
Hardware ID	E300SA22440031	RC firmware	6
Hardware revision	7	Lidar	
		Serial #	122222000242
		Revision	840-103574-06
		Firmware	v2.4.2

Statistics	
Total flight time	Arming
41h18m15s	392

At the bottom of the panel, there are links for Privacy, User Guide, and Customer Support.

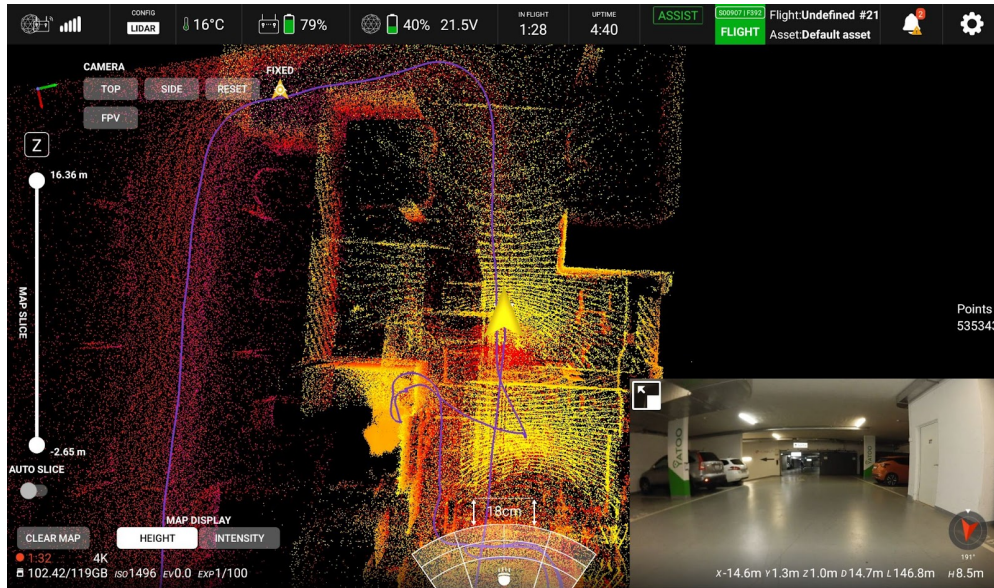
Normal FlyAware view

An additional view mode has been added to the live map. You can now view the live FlyAware point cloud in FPV mode.
